# THERMAL BARRIER INSTALLATION

UNDER MOSAIC STONE COATED STEEL ROOFING SYSTEM

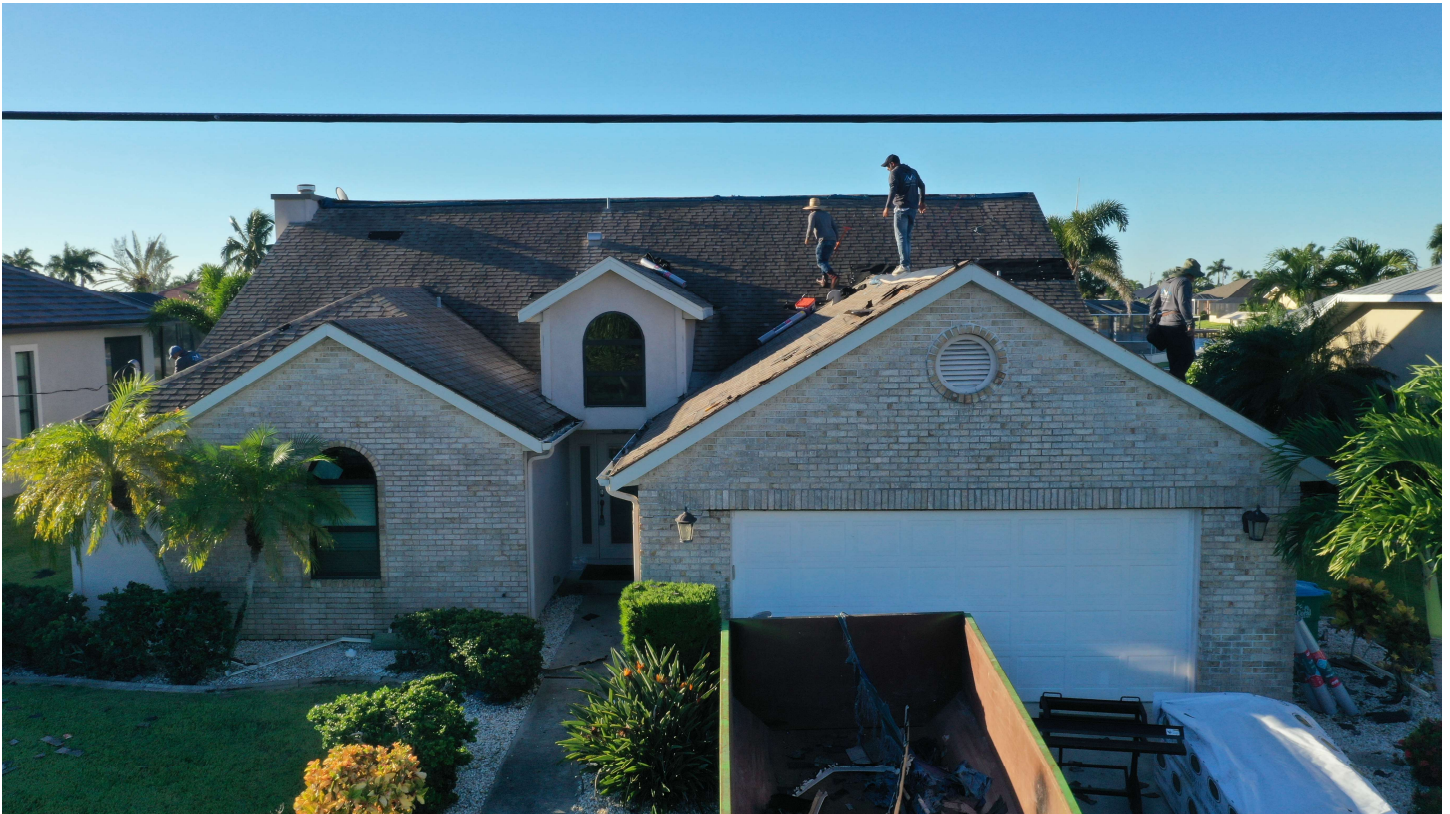
PRE-EXISTING COMPOSITE SHINGLE ROOFING SYSTEM (ASPHALT)

(AMBIENT OUTSIDE TEMPERATURE 62 DEGREES FARENHEIT)

Homeowner was experiencing a 30 degree Fahrenheit temperature variance between the outside temperature and the inside attic temperature with his existing composite shingle roof.

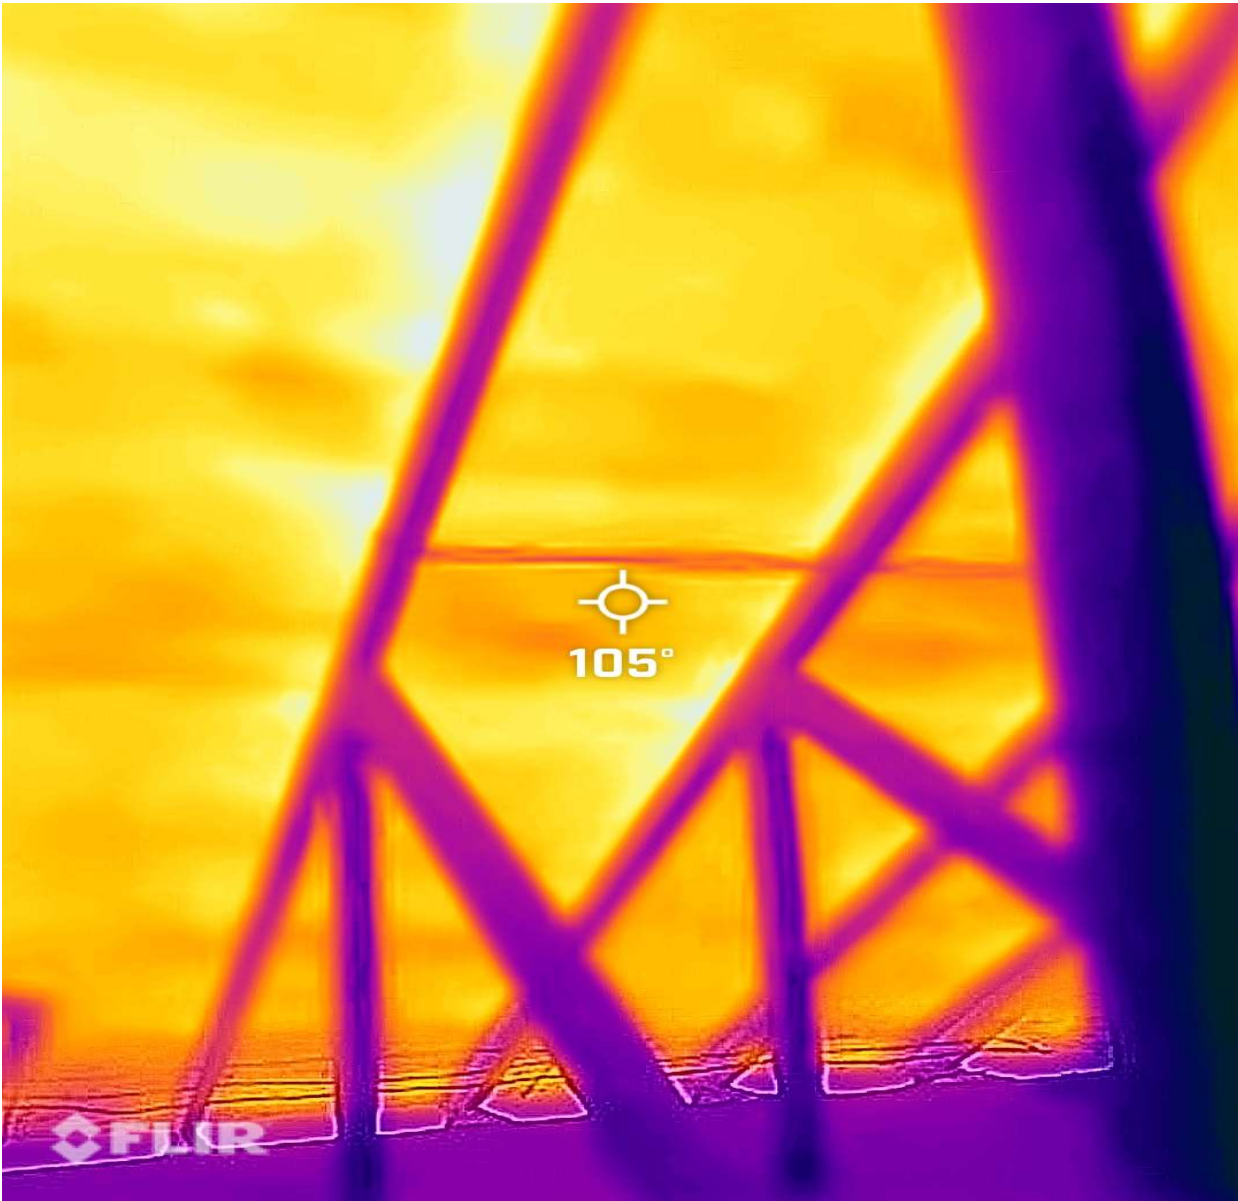
INTERIOR ATTIC TEMPERATURE UNDERSIDE OF ROOF DECKING (105 DEGREES FARENHEIT)

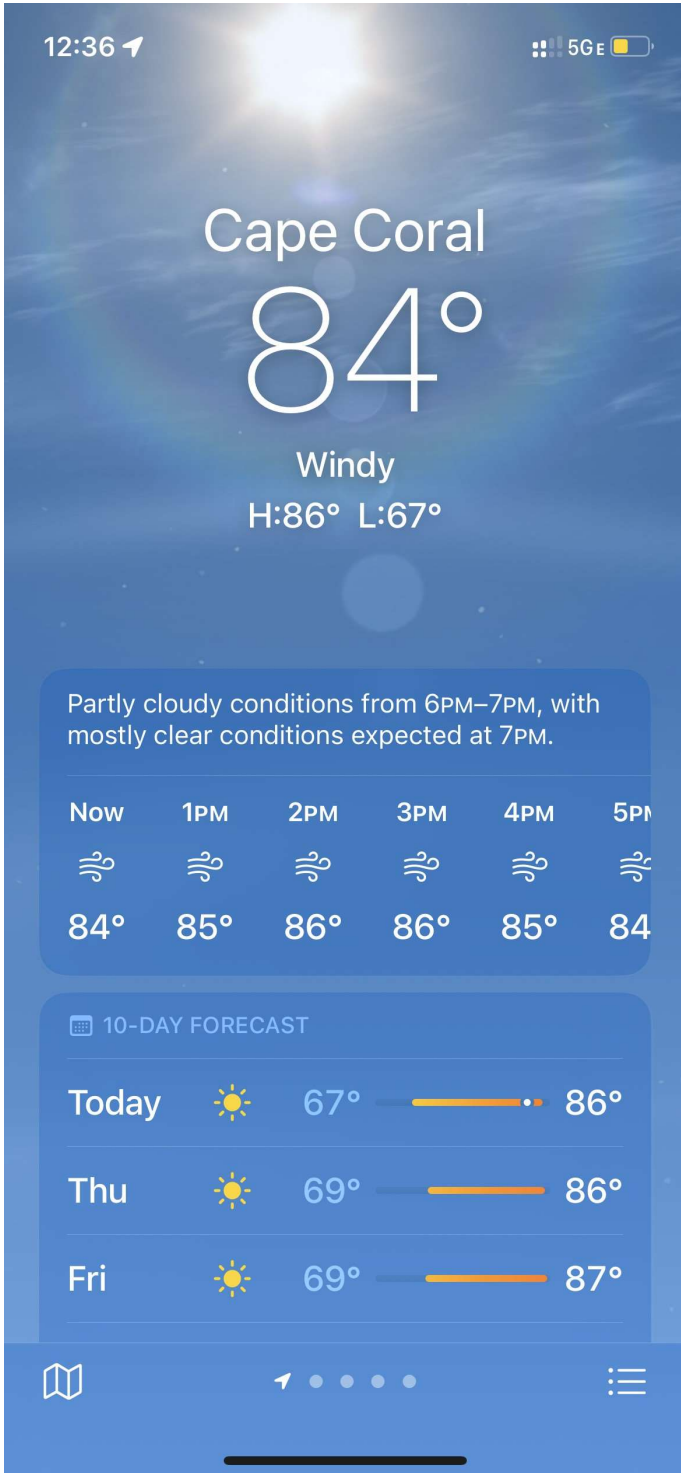
AMBIENT OUTSIDE TEMPERATURE (84 DEGREES FARENHEIT)

Two degree variance between outside air temperature and interior air space of attic after installation of thermal barrier, with interior attic temperature being cooler than outside air temperature.

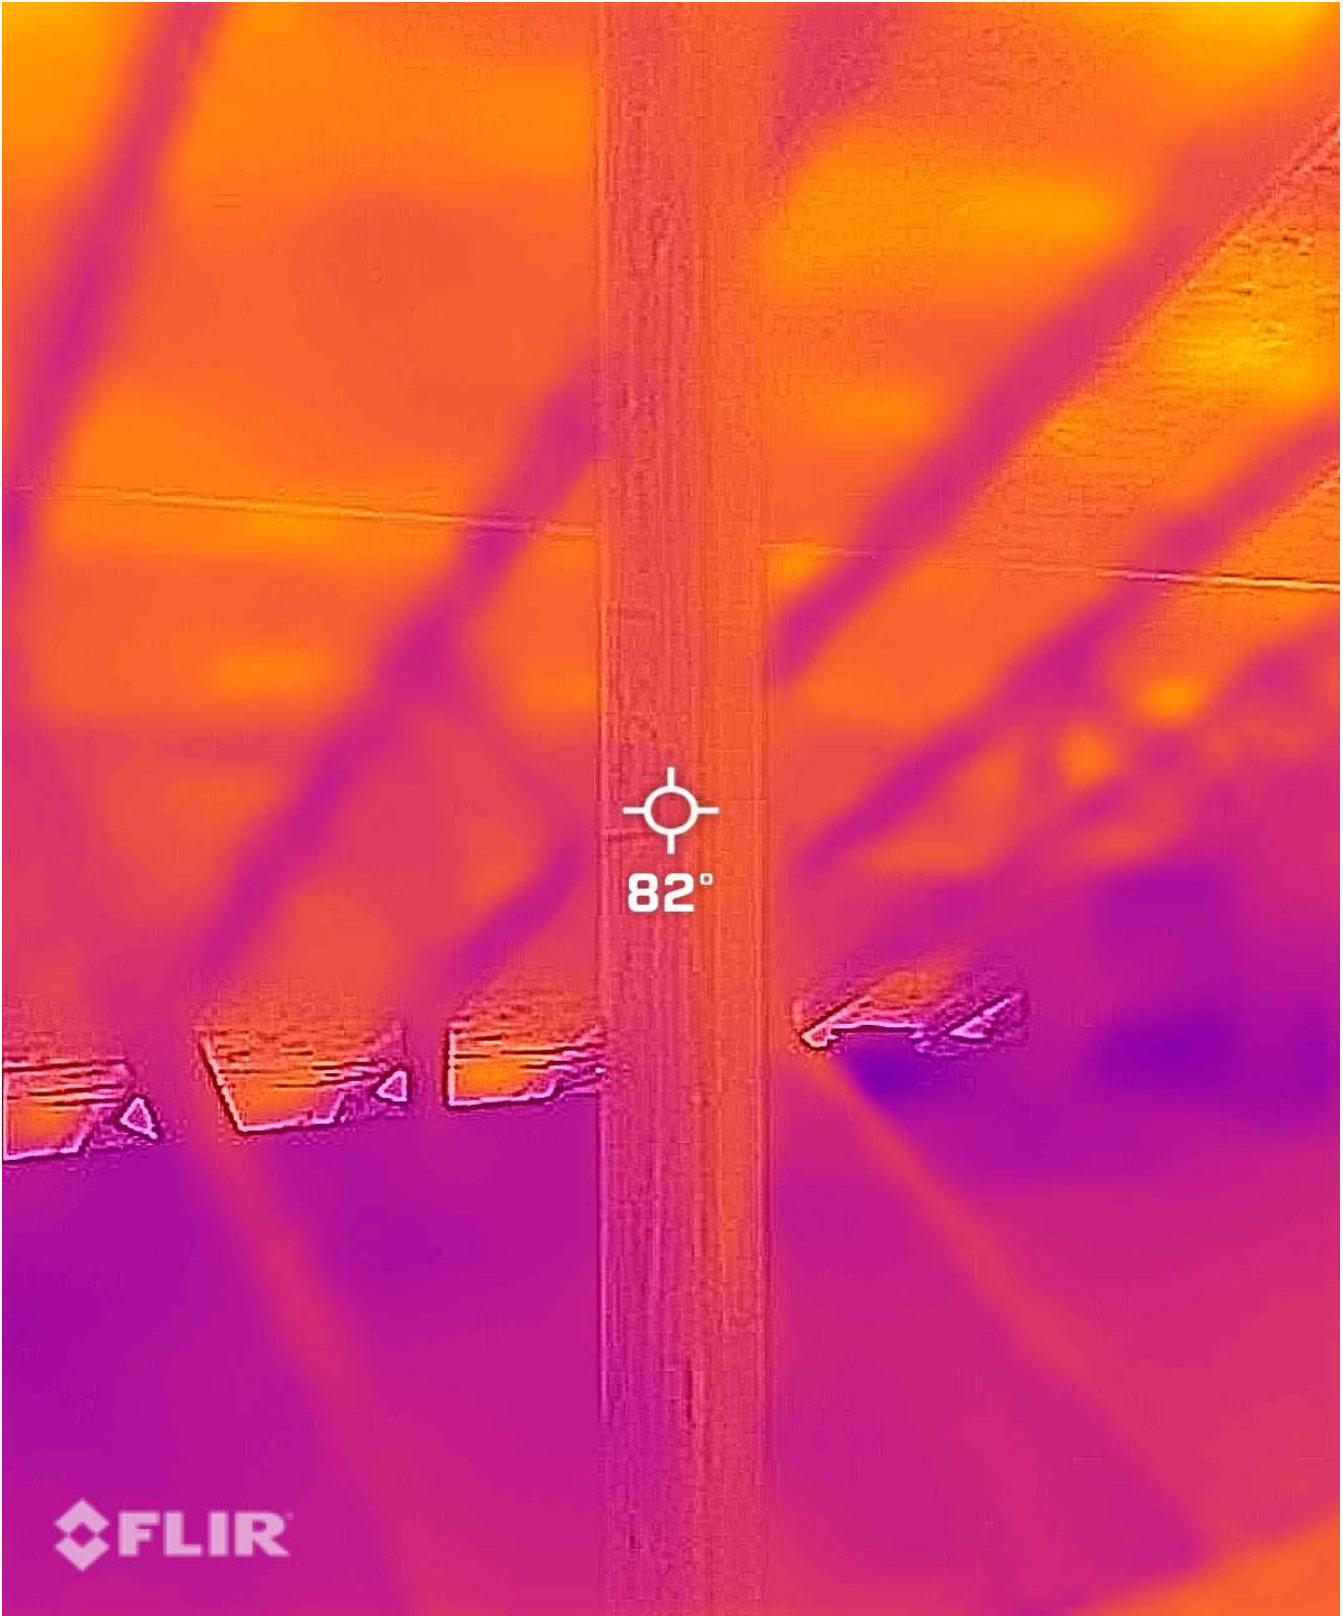
INTERIOR ATTIC TEMPERATURE MIDDLE OF AIR SPACE (82 DEGREES FARENHEIT)
